# **Oceanic Control System Issue Investigation Report**

Occurrence Date: 16 August 2025

INVESTIGATION REPORT DETAILS	
<b>Occurrence Classification</b>	Technology Occurrence (TO)
<b>Occurrence Date / Time</b>	16-Aug-25 04:24 UTC
<b>Location</b>	Oceanic (OCS)
<b>Investigation Number</b>	25/SI/370
<b>Involved / Attributable</b>	YES / YES
<b>Lead Investigator</b>	Senior Operational Safety Investigation Specialist, Safety & Assurance
<b>Supporting Investigators</b>	Operational Safety Advisor, Safety & Assurance ATS Subject Matter Expert, Safety & Assurance Senior Operational Safety Human Factors Specialist, Safety & Assurance
<b>QA and approval</b>	<b>Report Reviewed by:</b> Operational Safety Manager, Safety & Assurance  <b>Report approved for release by:</b> General Manager Safety & Assurance General Manager Air Traffic Services Chief Information and Technology Officer
<b>Distribution List</b>	Board Members, GM ATS, (A) CITO, GM S&A, Head of Legal, (A) GM Commercial HSS ATS, HAS ATS, SSS ATS, Head of ATS Support, OCS TL ATS NOMM TG, ATSDM TG, MEAN TG, NEM TG, MTSRG TG, OPSM S&A

<b>Final Report Date</b>	01 December 2025
<b>Version</b>	1.1

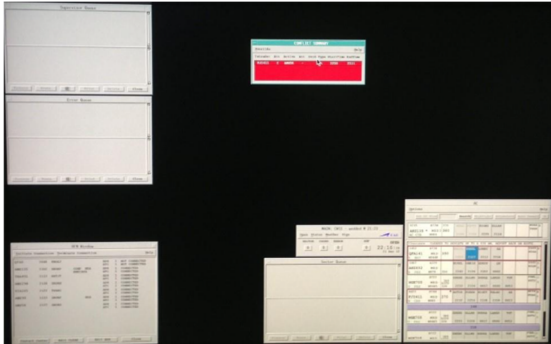
Figure 4: Data Display

*\*This is the display that initially went blank on Main CWS1 and CWS2*

After the event, Technician 3 reviewed the core files and traced the initial CWP failures to a long-latent timing defect – referred to as a ‘dangling pointer’ – in the display process. The defect had been in the code base for around 20 years.

The resulting failure of the data display application led to the loss of Main CWS1 and CWS2. This prevented the sectorisation process from completing, which subsequently led to Issue 2 below.

A small code change was implemented to mitigate the display application defect.

**ACTION 1:** Develop and implement a software patch to address the data display application issue, observed when sectorisation process failed to successfully complete.
